Plate bond to repair and protect a chute that has powder lime blown through it

ID: 9366

Industry: *General Industry*
Application: *SHM-Solids Handling Machinery*

Substrate: *Carbon steel*
Products: *Belzona 1212, Belzona 1812 (Ceramic Carbide FP)*

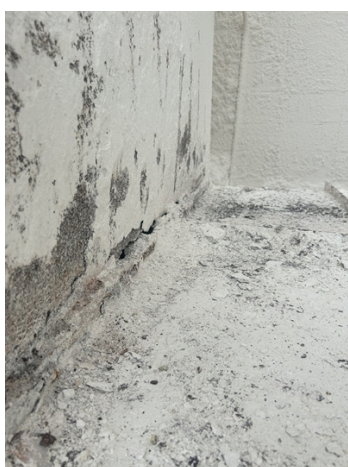
The chute which carries powder lime had a hole in it they needed to repair in place while adding abrasion protection with Belzona 1812

Area before being cleaned and prepared for work.

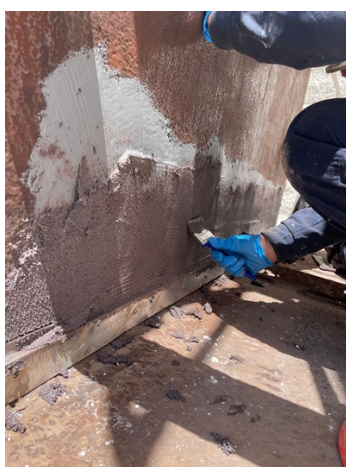
Area being prepared for application of Belzona 1212 and plate bond with Belzona 1812.

Belzona application tools and short bristled brushes were used for the hand application of Belzona 1812 and Belzona 1212.

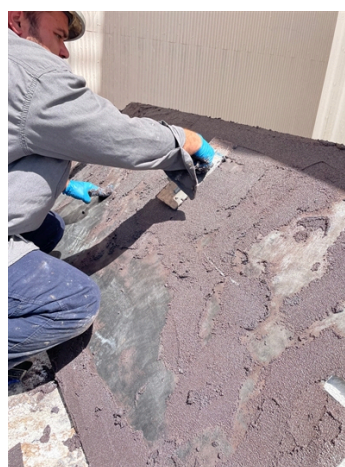
Belzona 1812 being applied to prepared plate to get ready to bond it to the chute.

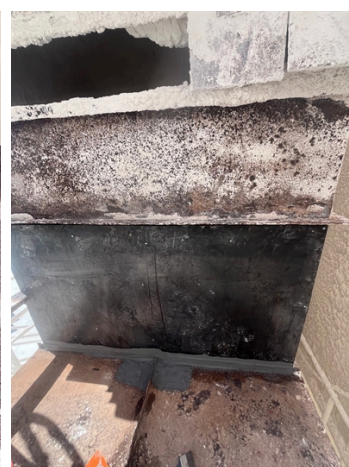
Job complete. Belzona 1212 and reinforcement cloth used to repair holes then a plate was boned with Belzona 1812 for abrasion protection.

The Belzona repair was the most cost effective due to being unable to weld in this area. They also wanted to add abrasion protection for the future, so a plate bond with Belzona 1812 was perfect for this.
