# BELZONA REFURBISHES LABORATORY WORKTOPS

Industry: *Water / Wastewater*  
Application: *WPA-Wall Problem Areas*  
Substrate: *unknown*  
Products: *Belzona® 5811 (Immersion Grade)*

Customer Location: *State Health Dept.*  
Application Date: *March 2005*

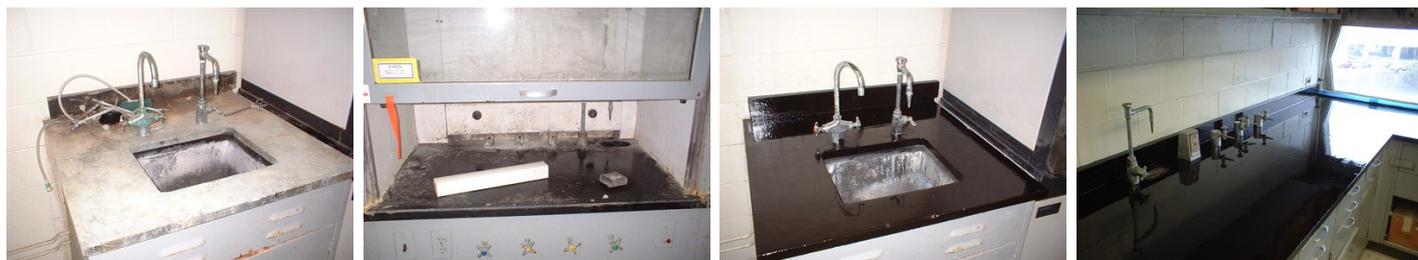
*Severely degraded counter tops needed to be resurfaced with a chemically resistant coating.*

\* Sink in lab before work , \* Fume cupboard before work , \* Sink after coating , \* Counter top after coating ,

Application carried out in accordance with modified Belzona System leaflet FPA-3. Special care was taken to clean sand the surfaces. Belzona® 5811 applied over-thickness with a trowel to create a self levelling coat.
