Belzona 2211 gets the trailer back to work.

ID: 9374

Application: *SHM-Solids Handling Machinery*

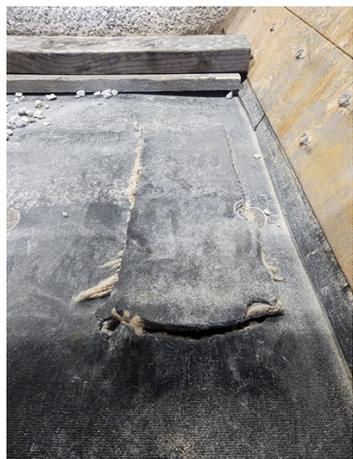
A tear had formed on the conveyor belt on the gravel hauling trailer.

Original condition of the belt showing the large area of damage.

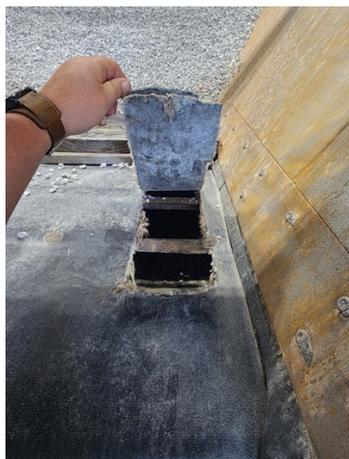
Lifting the torn flap of the conveyor belt to show the extent of the damage.

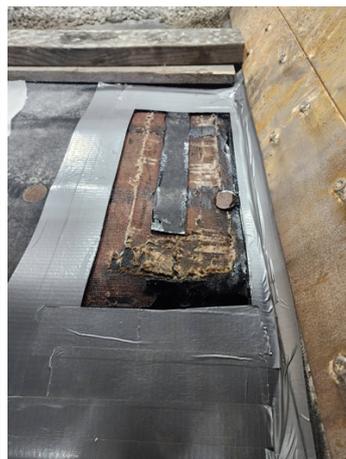
Top layer removed, Belzona 9341 reinforcement sheet pre-cut, border taped off, and Belzona 2911 QD conditioner applied.

All loose rubber was removed, and an area on either side of the tear had the top layer of the belt delaminated to accommodate the Belzona 2211 application and not interfere with the scraper. The exposed surface was cleaned and roughened using a grinder and stiff wire wheel leaving the exposed fabric and rubber rough. The Belzona 2911 QD conditioner was applied and allowed to dry as per the IFU before the Belzona 2211 and Belzona 9341 reinforcement sheet was applied. The duct tape was placed around the edges to achieve a clean application, and was removed as soon as the material was applied.

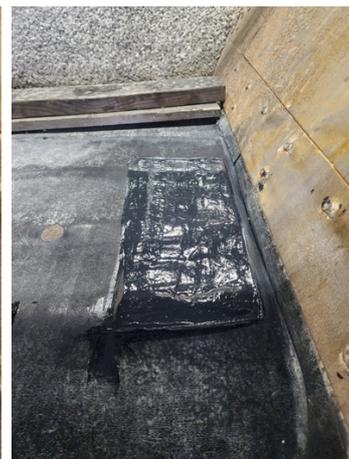
Belzona 2211 application completed.

Only one 550 gm unit of Belzona 2211 was used leaving the customer an extra one for any future applications. The application was completed in roughly two hours, and the trailer will be able to return to service within the following 36 hours. Alternative repair
