# Belzona Super wrap on a concrete stand for a pipe at a power station

ID: 9377

Industry: Power  
Application: WPA-Wall Problem Areas  
Substrate: Concrete  
Products: Belzona 1982 (SuperWrap II), Belzona SuperWrap

Customer Location: Oklahoma City  
Application Date: March 2024

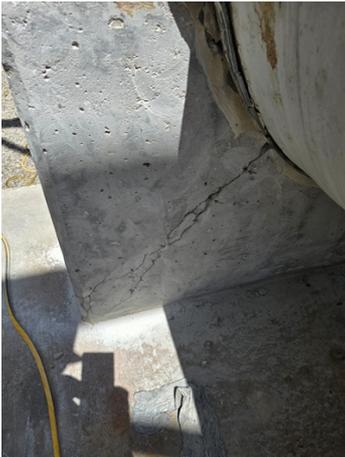
The concrete pedestal holding up a pipe formed a crack over the years of exposure to the elements.

Power plant water cooling pipe pedestal and crack

Cracks were injected and pinned before a two wrap system was applied.

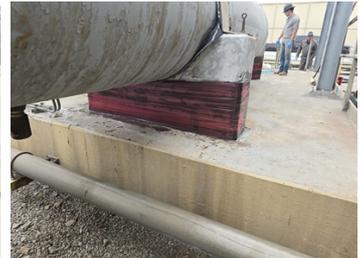
Final picture with consolidation tape
