# Belzona Super wrap on a concrete stand for a pipe at a power station

ID: 9377

Industry: Power

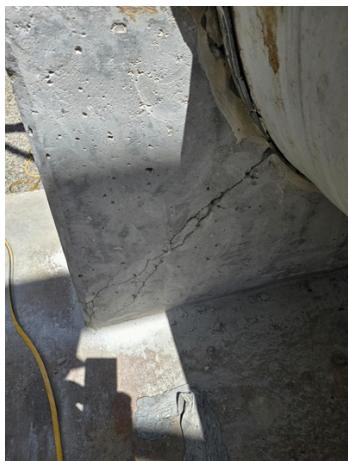
The concrete pedestal holding up a pipe formed a crack over the years of exposure to the elements.

Power plant water cooling pipe pedestal and crack

Cracks were injected and pinned before a two wrap system was applied.

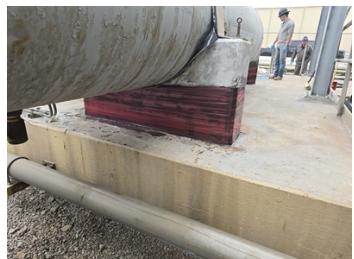
Final picture with consolidation tape
