# Premiership Football Club Stand still standing!

**Industry:** Buildings & Structures

**Application:** FPA-Floor Problem Areas

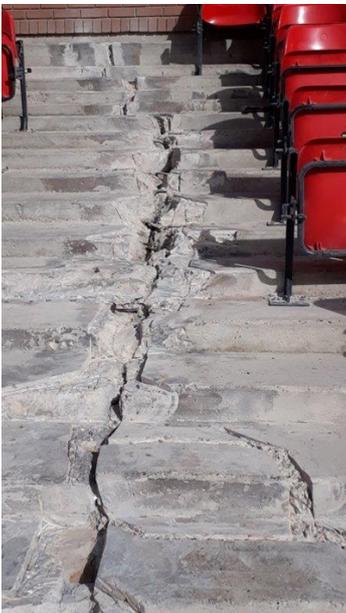
The original issue, with all loose and friable removed, ready for repairs to be made and a 30mm gap to be created

Break out loose and friable

Apply release agent to 30mm wide boards to great gap

Apply Belzona 4911 to all concrete repair target areas

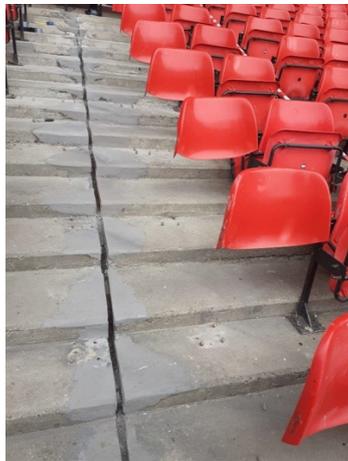
The shoulders have all now been made good and is ready for the bridging tape and the application of the Belzona 2211

Build up all square edges and corners using Belzona 4131

Mask up either side of the gap and apply bridging tape over the gap

Apply Belzona 2911 within the masked areas

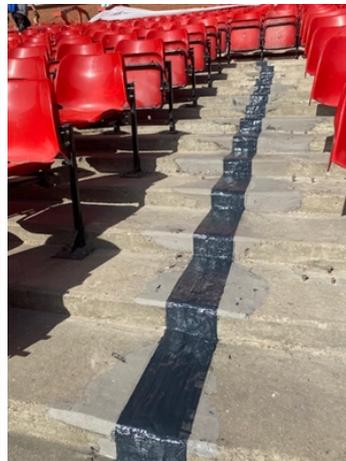
The completed repair and installation of the "accumulator gap"

Mix and apply Belzona 2211 and Belzona 9341 over the bridging tape and remove masking

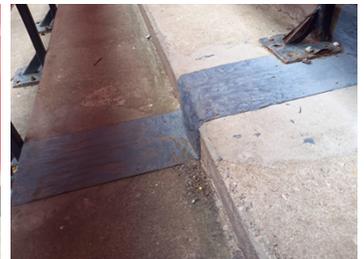
4 years later and the repair is as good now as it was at installation, with no issues created by movement and no further damage to the main football stand
