# Sealing of leaks to SF6 Gas Circuit Breaker in large substation

ID: 9380

Customer Location: Newark, Nottinghamshire  
Application Date: April 2024

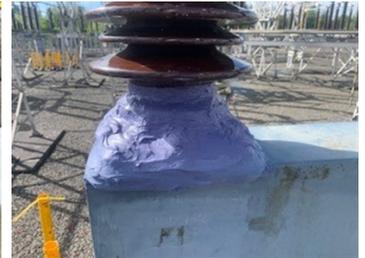
Cover nuts/bolts with belzona filled caps  
Wrap with bandage around whole area, overlapping and patching where necessary.

Build up Belzona product, ensuring no air pockets remain. Product given a week to cure before 5 bar restored to the Gas Circuit Breaker

Fill bolt caps and cover all bolts, then apply reinforcing sheet

Build up with Belzona 7311 to encapsulate all possible leaking sites

Allow to cure then introduce gas back to 5 bar working pressure
