# One Day Turnaround for Belzona Floor Repair at Iron Ore Mine

**Customer Location:** Iron ore mine in South Africa

**Application:** FPA-Floor Problem Areas

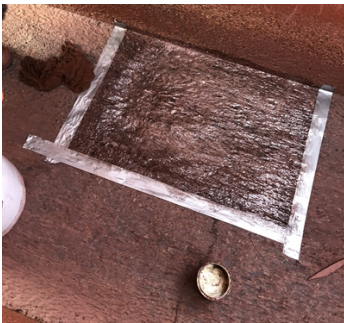
Smaller are prepared ready for Belzona application

Surface preparation was carried out by hand as the substrate was concrete with blue stone in it. Belzona 4911 (Magma TX Conditioner) was first applied to the area, and then Belzona 4131 (Magma-Screed) one metre at a time. Distributor's own application team carried it the application on site.

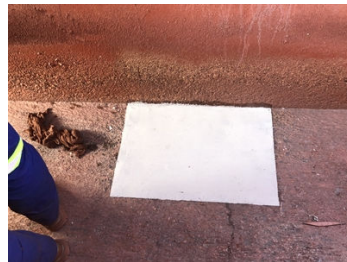
Belzona 4131 applied to damaged area.

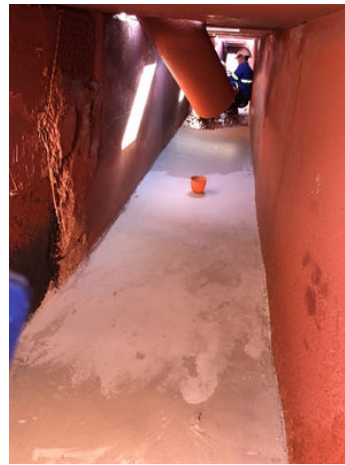
Application in progress

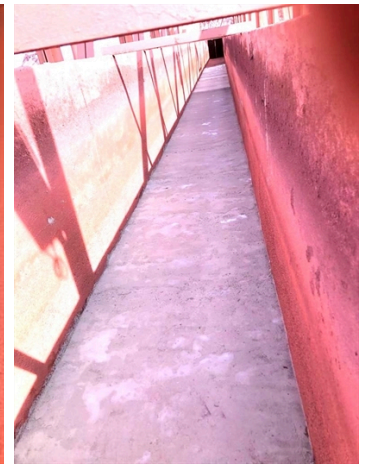
Completed repair with Belzona 4131 in service for 5 years

These initial repairs have been in service for 4-6 years and they show no signs of wear.
