Belzona Roof Repair in Ore Mine

Customer Location: Ore Mine in South Africa

Application: RPA-Roof Problem Areas

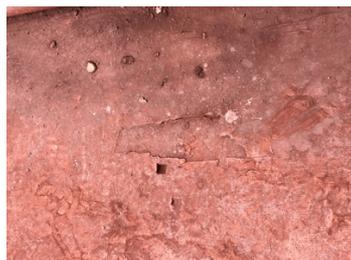
The old weather proofing systems had failed and there was water and dust entering these substation roof through the seams and joints.

Leaking roof area

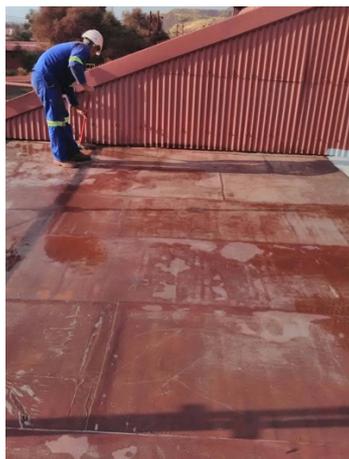
Surface preparation

The original coating was removed as it was loose. On completion of surface preparation including washing and degreasing, Belzona 3111 (Flexible Membrane) was used in conjunction with the Belzona 3911 (PSC Conditioner) and Belzona 9311 (Reinforcement Sheet). This facilitated swift waterproofing of the compromised roof sections. The application area was 150 square metres.

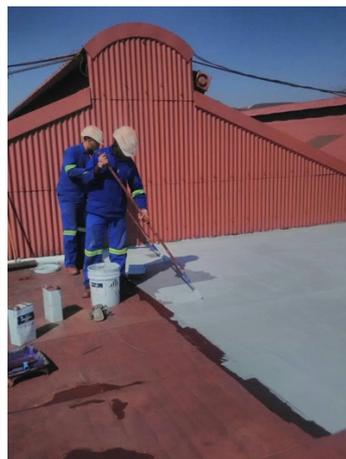
Application in progress

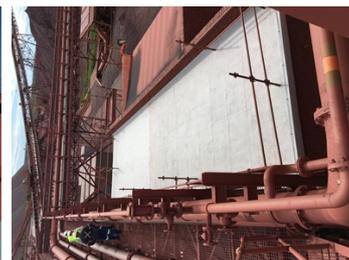
Another area being coated
