# BELZONA PUMP REPAIR COMPLETED WITH PORTABLE LATHE

ID: 939

Customer Location: *Coal Power Plant, West Virginia*  
Application Date: *March, 2003*

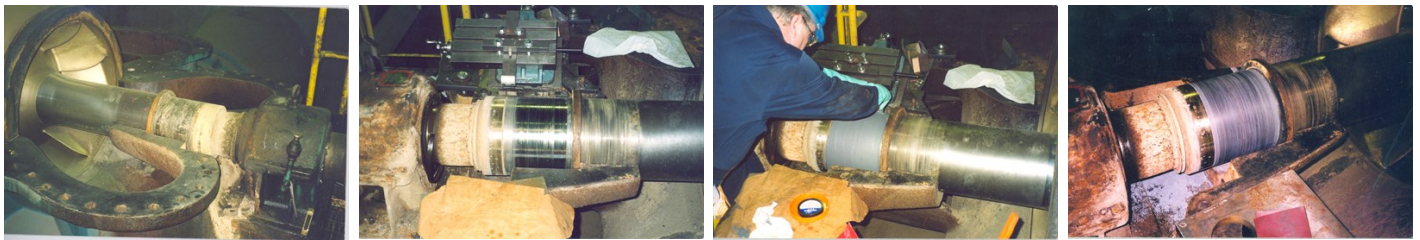
## Photograph Descriptions

*Damage on packing gland area due to overtightning of packing and contaminated river water*

\* Damage to cooling tower pump shaft , \* Set up and undercutting shaft , \* Applying Belzona® 1111 , \* Finished shaft repair ,

Two 14" diameter shafts for cooling towers pumps

Application carried out in accordance with the Belzona Know-How System Leaflet MPT-1. A portable lathe was used to machine shafts in place.
