Power station sea water pipe

ID: 9398

Customer Location: Lavrio
 Application Date: March 2024

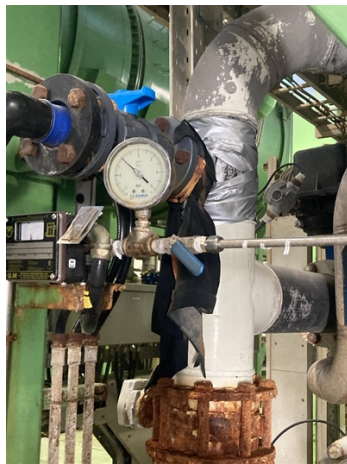
Facility had a leakage issue with a sea water pipe. They had applied tape to minimize the leak, which was not an adequate solution.

Component initial condition

Tape removal, substrate surface preparation, application of Belzona 1161 with reinforcement tape 9341 according to IFU.

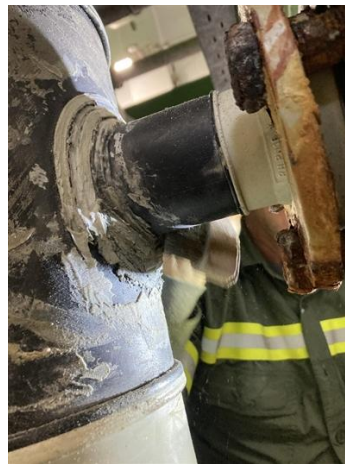
Surface preparation

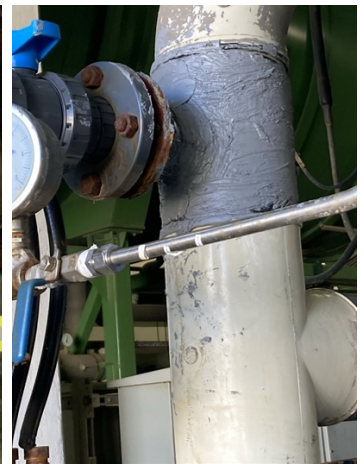
Component repaired
