Power station sea water pipe

ID: 9398

Industry: Power
Application: VPF-Valves, Pipes and Fittings
Substrate: PVC
Products: Belzona 1161 (Super UW-Metal)

Customer Location: Lavrio
Application Date: March 2024

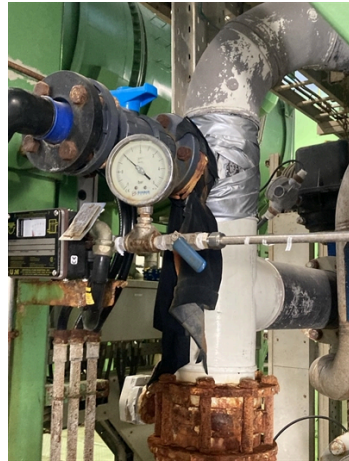
Facility had a leakage issue with a sea water pipe. They had applied tape to minimize the leak, which was not an adequate solution.

Component initial condition

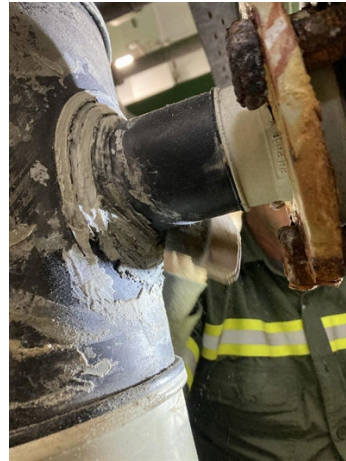
Surface preparation

Tape removal, substrate surface preparation, application of Belzona 1161 with reinforcement tape 9341 according to IFU.

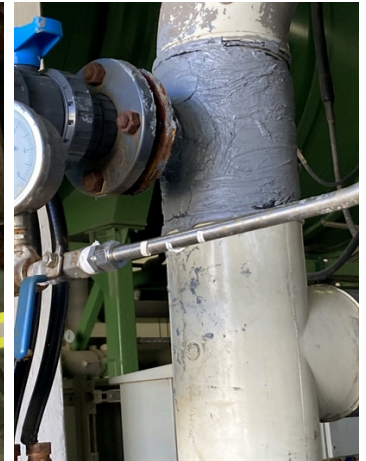
Component repaired
