# Power station sea water pipe

ID: 9398

Customer Location: Lavrio  
 Application Date: March 2024

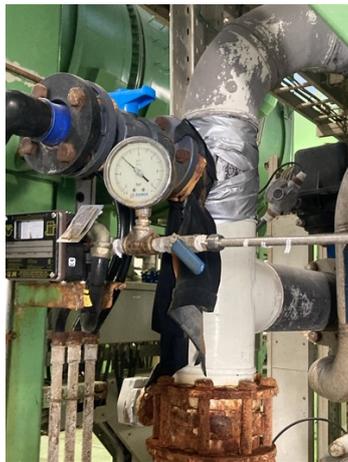
Facility had a leakage issue with a sea water pipe. They had applied tape to minimize the leak, which was not an adequate solution.

Component initial condition

Tape removal, substrate surface preparation, application of Belzona 1161 with reinforcement tape 9341 according to IFU.

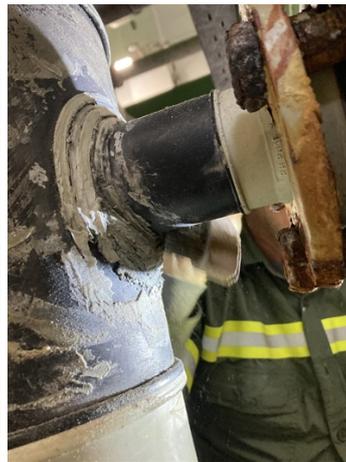
Surface preparation

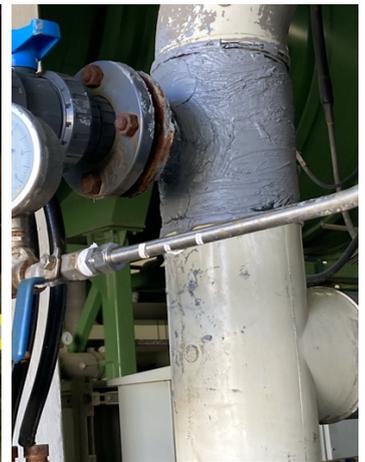
Component repaired
