Tube Stack Faces

ID: 9401

Industry: Power
Application: HEX-Heat Exchangers
Substrate: Carbon steel
Products: Belzona 1311 (Ceramic R-Metal), Belzona 1321 (Ceramic S-Metal)

Customer Location: UK
Application Date: May 2024

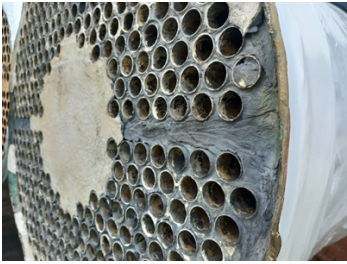
During the Planned Outage of the station, the tube stacks were inspected and due to sea water been used for cooling the faces were found to have significant erosion and corrosion.

Condition of the faces upon arrival at the workshop

Grit Blast all faces to SA2.5 with a profile of 75 Microns.
Remove all debris.
Cork all holes.
Rebuild areas with 1311
Apply 2 coats of 1321 as per IFU

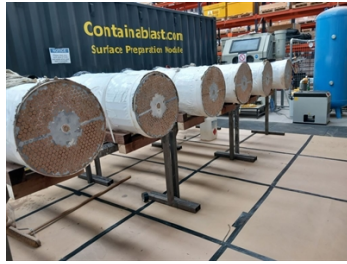
A total of over 3000 corks where required for plugging the faces

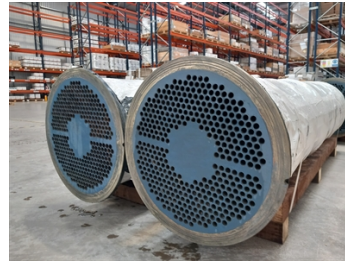
Faces after coating
