Crack repair - Sea water distiller

ID: 9404

Industry: Power
Application: TCC-Tanks and Chemical Containment Areas
Substrate: Cast Iron
Products: Belzona 1161 (Super UW-Metal), Belzona 1391T

Customer Location: LAVRIO GREECE
Application Date: May 2024

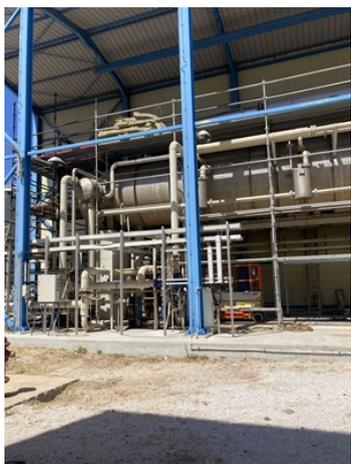
The customer faced cracks at sea water distiller . Due to the cacks the sea water was mixed with the clean water and the unit were out of order.

Sea water distiller

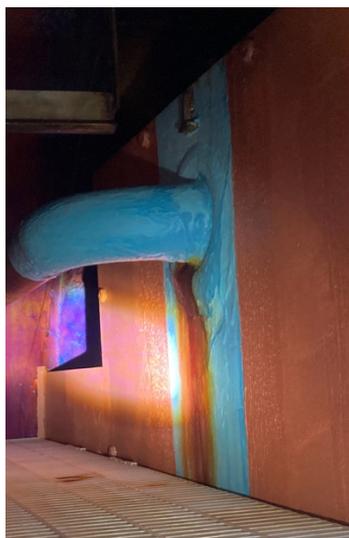
Before the surface preparation

Surface preparation , Use Belzona 1161 with Belzona 9341 to close the cracks , coating with Belzona 1391T

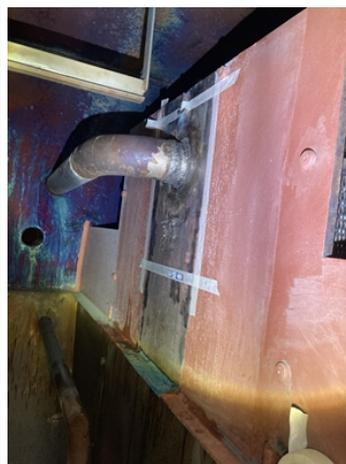
Before preparing surface

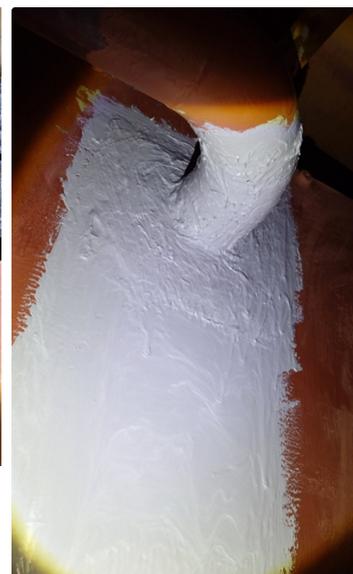
Surface coated with Belzona 1391T
