Crack repair - Sea water distiller

ID: 9404

Industry: Power
Application: TCC-Tanks and Chemical Containment Areas
Substrate: Cast Iron
Products: Belzona 1161 (Super UW-Metal), Belzona 1391T

Customer Location: LAVRIO GREECE
Application Date: May 2024

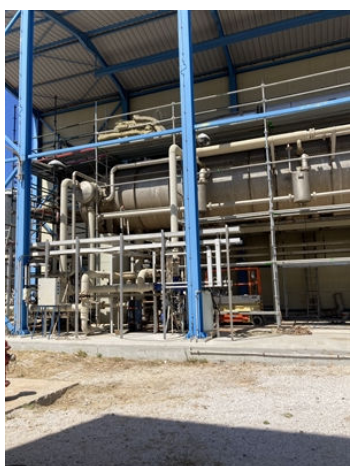
The customer faced cracks at sea water distiller . Due to the cacks the sea water was mixed with the clean water and the unit were out of order.

Sea water distiller

Surface preparation , Use Belzona 1161 with Belzona 9341 to close the cracks , coating with Belzona 1391T

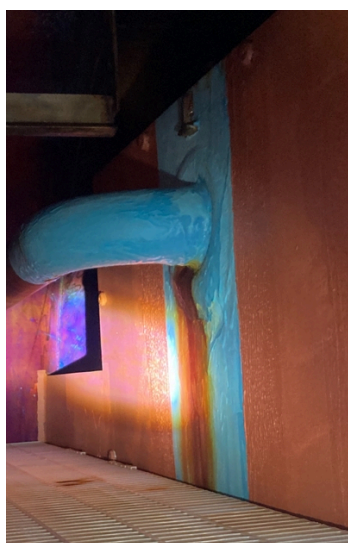
Before the surface preparation

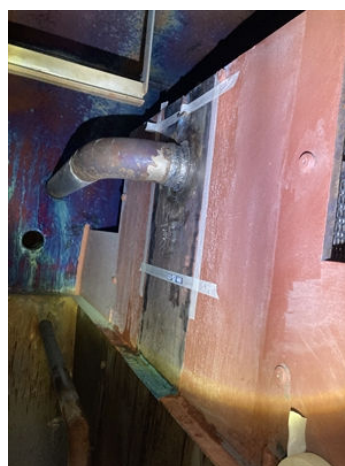
Before preparing surface

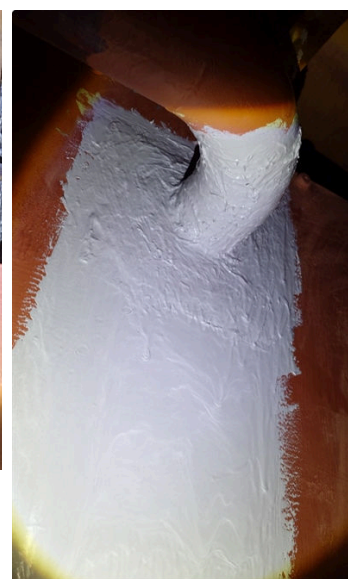
Surface coated with Belzona 1391T
