# Concrete Floor Repairs

ID: 9406

**Industry:** *General Industry* **Customer Location:** *Southwestern Ontario*  
**Application:** *FPA-Floor Problem Areas* **Application Date:** *April 2023*  
**Substrate:** *Concrete*  
**Products:** *Belzona 4111 (Magma-Quartz), Belzona 4911 (Magma TX Conditioner), Belzona 9111 (Cleaner Degreaser)*

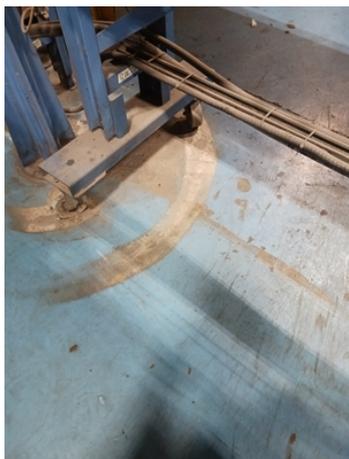
Floor area showing where the grooves have been repaired on this conveyor.

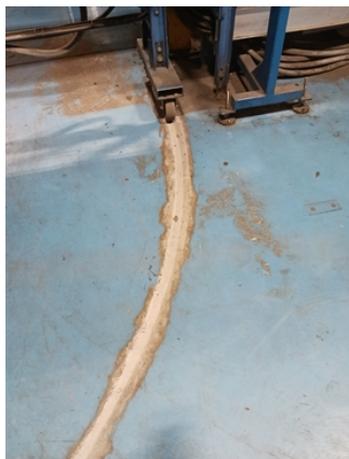
Floor area showing where the grooves have been repaired on this conveyor.

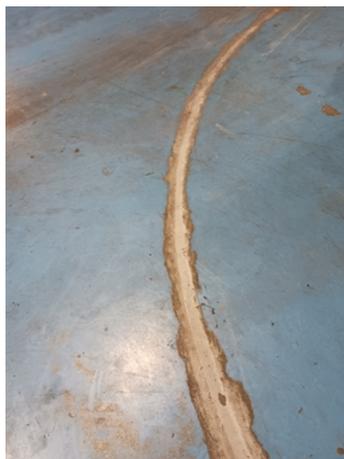
Floor area showing where the grooves have been repaired on this conveyor.
