# Belzona blocks the leaks in secondary containment

ID: 9407

Application: *FPA-Floor Problem Areas*

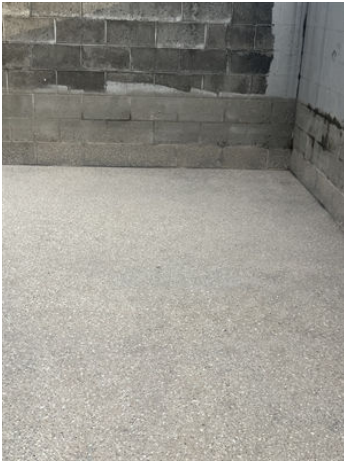
Grit blasting the floor to get correct surface profile.

Abrasive profile/Eco-Blast all areas that were to be coated. Rebuilt damaged area with Belzona 4124 and coated two coats of Belzona 5811. Block wall with cracks were filled with Belzona 4111, coated with Belzona 5815 with 9341 reinforced system,

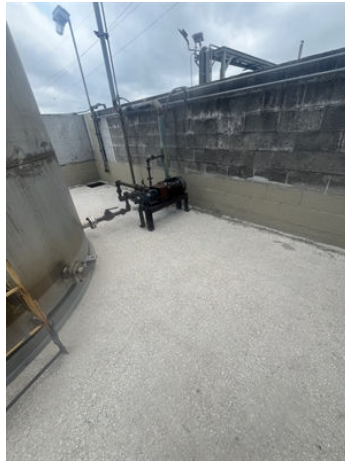
Area after grit blasting

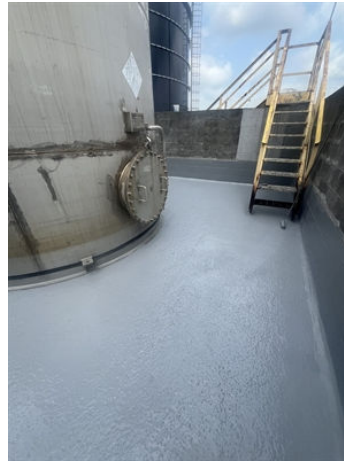
Floor after the second coat

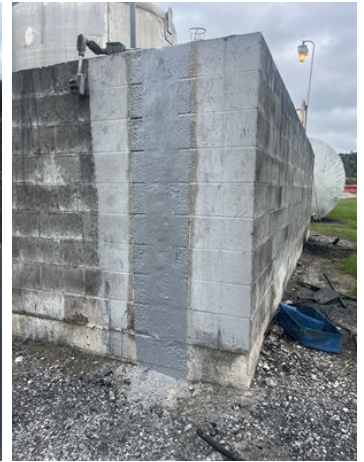
*The secondary containment had formed some cracks over time in the block wall and where the concrete meets the wall.*

The crack in the outside of wall that was repaired with Belzona and coated
