Belzona blocks the leaks in secondary containment

ID: 9407

Customer Location: Franklin Louisiana

Application: FPA-Floor Problem Areas

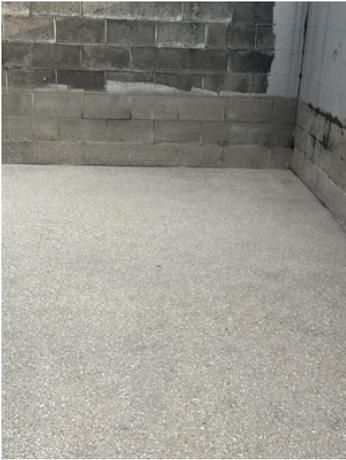
Grit blasting the floor to get correct surface profile.

Abrasive profile/Eco-Blast all areas that were to be coated. Rebuilt damaged area with Belzona 4124 and coated two coats of Belzona 5811. Block wall with cracks were filled with Belzona 4111, coated with Belzona 5815 with 9341 reinforced system,

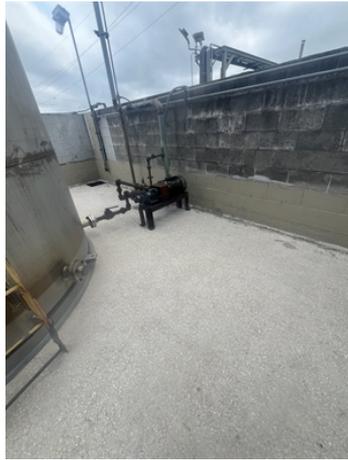
Area after grit blasting

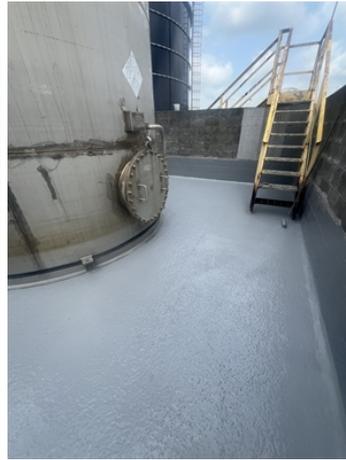
Floor after the second coat

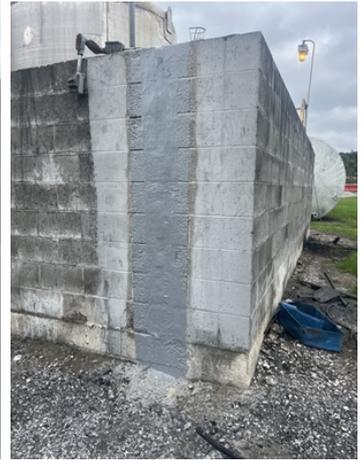
The secondary containment had formed some cracks over time in the block wall and where the concrete meets the wall.

The crack in the outside of wall that was repaired with Belzona and coated
