# BELZONA TANK PLATE BONDING

ID: 941

**Customer Location:** Oil Distributor, Merseyside, England  
**Application Date:** October 2006

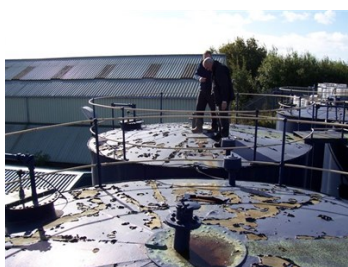
Existing coating had delaminated from tank roofs exposing steelwork underneath. This in turn corroded resulting in holed tank roofs.

- \* General condition of tank roofs ,
- \* Blasting the substrate ,
- \* Plates in position & Belzona® 5811 being applied ,
- \* Completed application ,
