# Stainless Steel Propeller Repair and Protection

ID: 9411

Industry: *Marine*  
Application: *SOS-Ships and Offshore Structures*

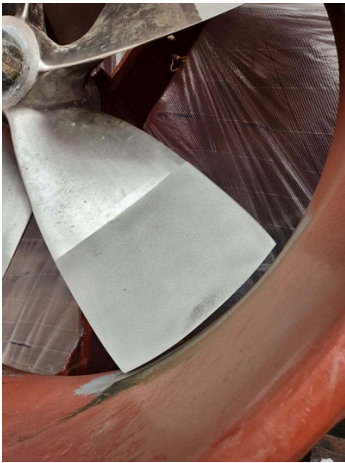
*Areas of cavitation damage*

Vessel owner was in a rush to get the vessel back in service. Removing the propellers for outside repairs would not fit the timeframe allowed. Based on previous case studies, the owner and shipyard agreed on the application.

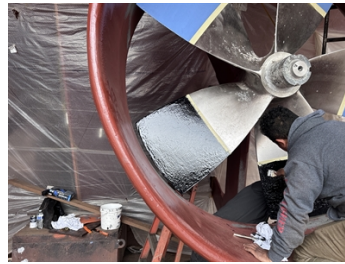
1st coat applied was Belzona 1341

Tips of blades were grit blasted to a minimum of 3mils. Cavitation pockets were filled with Belzona 1311. For protection, Belzona 1341 was applied in a 10mil coat. Belzona 2941 surface conditioner was then applied followed by a 30mil coat of Belzona 2141.

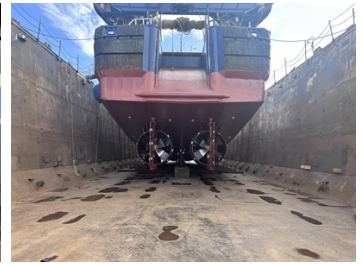
2nd coat applied was Belzona 2141
