Belzona Florida Repairs Steel Mill

ID: 9416

Industry: *Steel & Metal Processing*
Application: *ENC-Engines and Casings*
Substrate: *Stainless-steel*
Products: *Belzona 1212*

Customer Location: *Duval County, Florida*
Application Date: *2021*

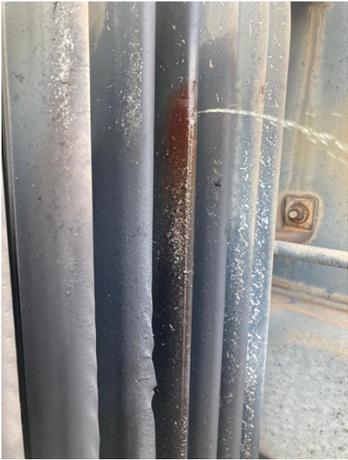
The transformer could not be shut down and the leak was live. It was constantly spitting a stream of cooling oil.

Leaking transformer

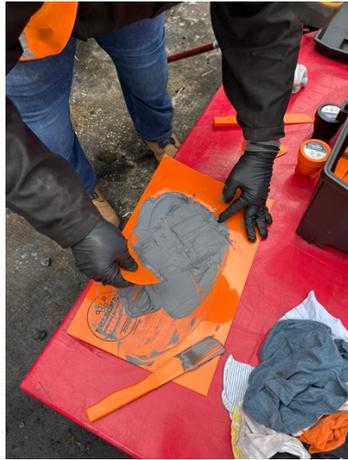
Mixing the product together

While on site, we did not have Belzona 9611 available, so we prepared a batch of Belzona 1212. We allowed the mixture to reach the six-minute mark of its working life, during which it warmed up and began to cure. At this point, the Belzona 1212 material had hardened sufficiently to be used as a plug. Using a Belzona applicator, we pressed the Belzona 1212 into the live leak hole, effectively sealing it instantly. We also provided instructions to the onsite technicians on how to mix and apply the material. This repair was performed three years ago and remains effective to this day.

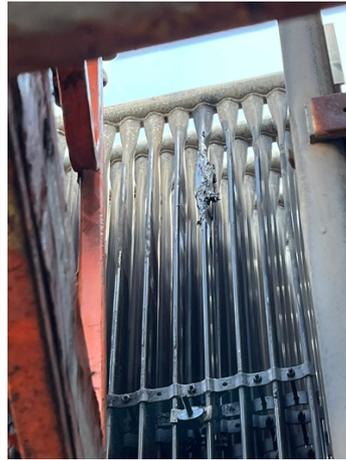
Area completely repaired using the product

The leak persisted continuously, and shutting down the transformer was not feasible. According to the onsite engineer, an alternative repair approach, involving shutting down the transformer and draining the cooling oil to a level that would allow cleaning the area and welding the hole, was estimated to cost approximately \$30,000. Instead, we effectively plugged the leak using a single 450g unit of Belzona 1212, which cost approximately \$130.
