Belzona Florida Repairs Steel Mill

Industry: Steel & Metal Processing
Application: ENC-Engines and Casings
Substrate: Stainless-steel
Products: Belzona 1212

Customer Location: Duval County, Florida
Application Date: 2021

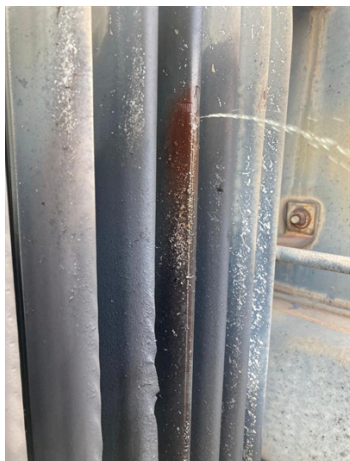
The transformer could not be shut down and the leak was live. It was constantly spitting a stream of cooling oil.

Leaking transformer

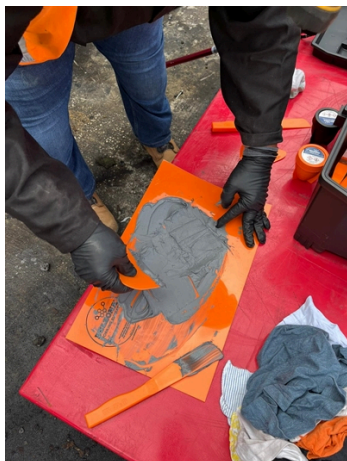
Mixing the product together

While on site, we did not have Belzona 9611 available, so we prepared a batch of Belzona 1212. We allowed the mixture to reach the six-minute mark of its working life, during which it warmed up and began to cure. At this point, the Belzona 1212 material had hardened sufficiently to be used as a plug. Using a Belzona applicator, we pressed the Belzona 1212 into the live leak hole, effectively sealing it instantly. We also provided instructions to the onsite technicians on how to mix and apply the material. This repair was performed three years ago and remains effective to this day.

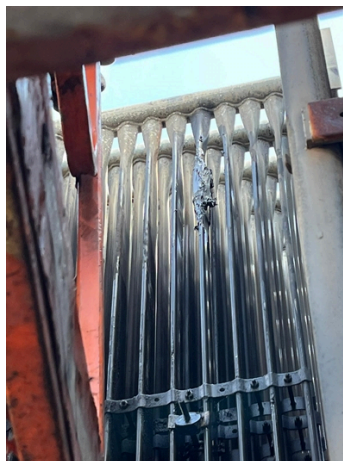
Area completely repaired using the product
