Belzona replaced the old damaged rubber protection.

ID: 9417

Industry: *Power*
Application: *TCC-Tanks and Chemical Containment Areas*
Substrate: *Carbon steel*
Products: *Belzona 4311 (Magma CR1)*

Customer Location: *Kosice Slovakia*
Application Date: *August 2023*

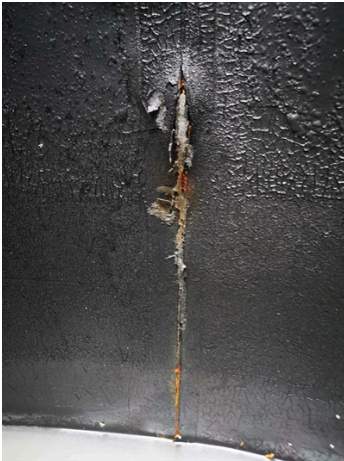
Damaged rubber coating

Damaged rubber protection.

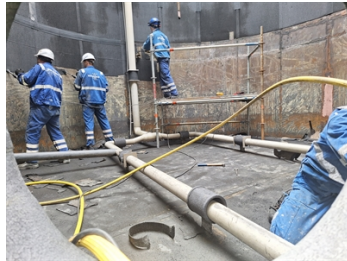
Removing the rubber surface.

The repair of 55m² took 5 days, of which the most time was taken by chopping off the old rubber.

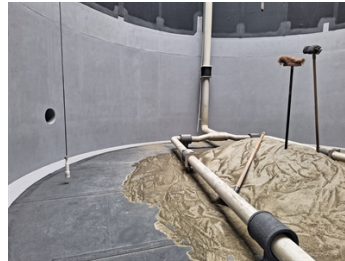
The surface is ready for the application of Belzona products.

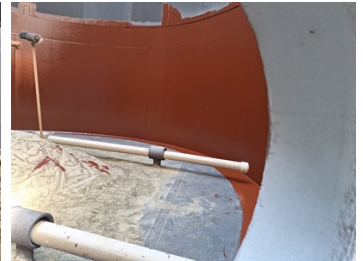
Belzona 4311 product application.

After removing the old damaged rubber, 2 layers of paint were applied.
