Belzona replaced the old damaged rubber protection.

ID: 9417

Industry: *Power*
Application: *TCC-Tanks and Chemical Containment Areas*
Substrate: *Carbon steel*
Products: *Belzona 4311 (Magma CR1)*

Customer Location: *Kosice*
Application Date: *August 2023*

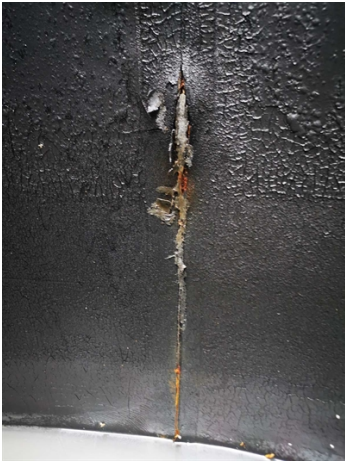
Damaged rubber coating

Damaged rubber protection.

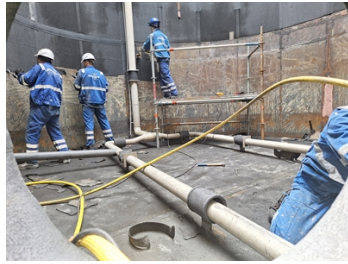
Removing the rubber surface.

The repair of 55m² took 5 days, of which the most time was taken by chopping off the old rubber.

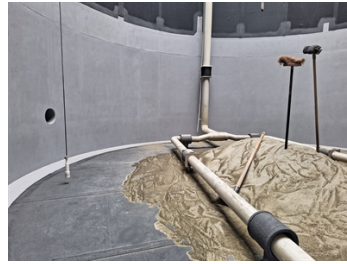
The surface is ready for the application of Belzona products.

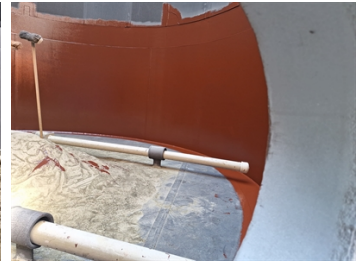
Belzona 4311 product application.

After removing the old damaged rubber, 2 layers of paint were applied.
