Sealing of gas pipe expansion joints.

ID: 9418

Customer Location: Kosice Slovakia

Application Date: August 2023

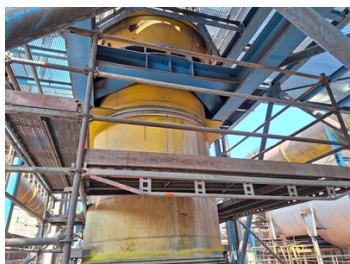
At the pipe/expansion joint, due to expansion and weather conditions, the expansion jointer was torn off locally and a subsequent leak occurred.

The expansion jointer was torn off locally and a subsequent leak occurred.

The only alternative to repairing the expansion joints was to replace them, which is very demanding from a technical and time point of view, due to the dismantling of the pipe above the expansion joint, the dismantling of the compensator itself, the welding of a new one and the subsequent assembly of the disassembled pipe. All using cranes.

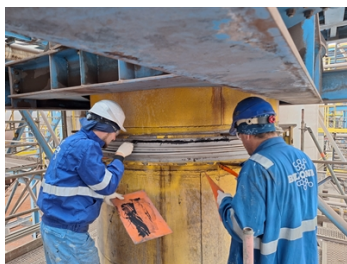
Belzona 2311 was pressed into the leaks

The surface of the pipeline and compensator was cleaned and roughened by blasting (during the shutdown of the degassed pipe). Belzona 2311 was pressed into the leaks, which was then covered with Belzona 7311 with reinforcement sheet.

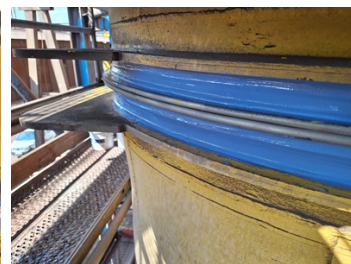
The damaged compensator was finally repaired with the product Belzona 7311.

Using Belzona products to repair compensator damage resulted in a quick and inexpensive solution compared to replacing the damaged parts.
