Application of the Belzona coating on the HCl tank.

ID: 9419

Application: *TCC-Tanks and Chemical Containment Areas*

Substrate: *Carbon steel*

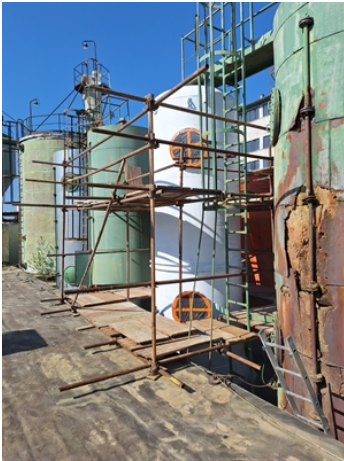
Process tanks are located on the roof.

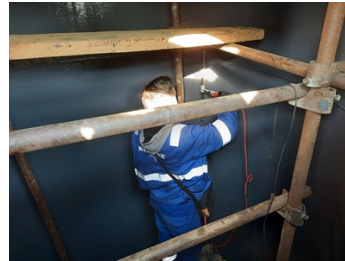
Application of the first layer of Belzona 4311 product.

After removing the old damaged rubber, 3 layers of paint were applied. Local repairs were carried out with Belzona 1111

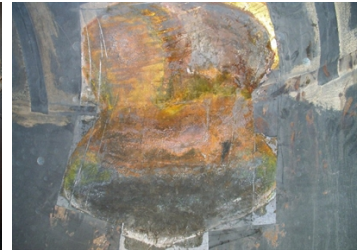
Checking the integrity of the coating after applying the second layer.

Local repairs were carried out with Belzona 1111
