# BELZONA STEP NOSING REPAIR

Industry: Buildings & Structures  
Application: FPA-Floor Problem Areas  
Substrate: Concrete  
Products: Belzona® 4111 (Magma Quartz)<div>Belzona® 4411 (Granogrip)</div>

Customer Location: Racecourse, Liverpool, England  
Application Date: March 2007

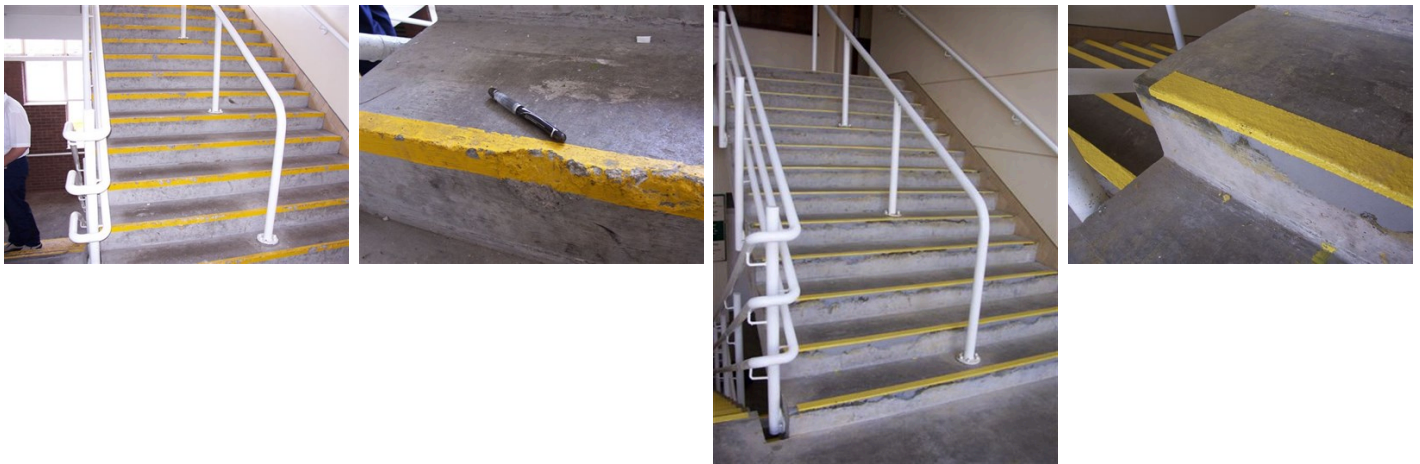
Porters had been bouncing beer barrels down the steps from the bar situated on the floor above. This was damaging the concrete step nosings.

\* Steps showing signs of damage , \* Close up of damage , \* Steps repaired , \* Close up of repair ,

Damaged step nosings.

Application was carried out in accordance with Belzona Know-How System Leaflets FPA-1 & -8.

Belzona was chosen due to its high bond strength, impact resistance and hard wearing non-slip surface proven in similar environments.
