BELZONA STEP NOSING REPAIR

ID: 942

Customer Location: Racecourse, Liverpool, England
Application Date: March 2007

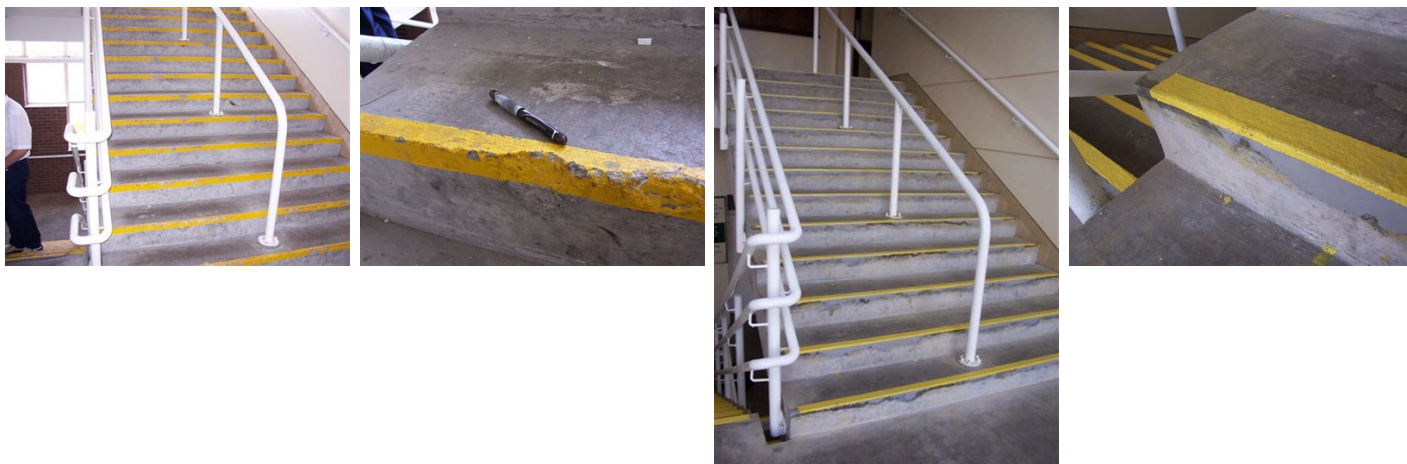
Porters had been bouncing beer barrels down the steps from the bar situated on the floor above. This was damaging the concrete step nosings.

* Steps showing signs of damage , * Close up of damage , * Steps repaired , * Close up of repair ,

Damaged step nosings.

Application was carried out in accordance with Belzona Know-How System Leaflets FPA-1 & -8.

Belzona was chosen due to its high bond strength, impact resistance and hard wearing non-slip surface proven in similar environments.
