## Flanges leak sealed in a petrochemical plant.

ID: 9423

**Industry:** Chemical & Petrochemical

**Application:** VPF-Valves, Pipes and Fittings

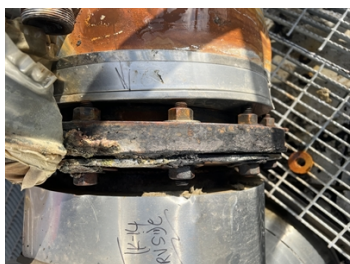
Product was leaking from flanges and needed sealing for environmental compliance.

One of the flanges before surface preparation.

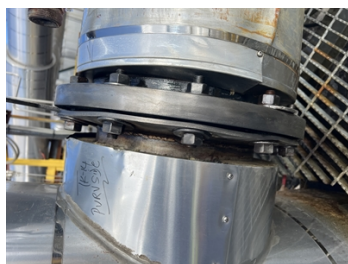
Flange after surface preparation.

- Flanges were cleaned using Belzona 9111 and a power tool.
- Belzona 1212 was used to seal the leak.
- Belzona Superwrap II resin and accessories were used to give further protection.

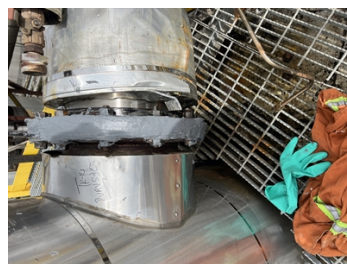
Flange after sealing with Belzona 1212.

Belzona repair solution was able to achieve seal the leaks under 6 minutes , allowing for a more robust superwrap application. The overall repair was carried out based on customer's expectation and no leak was experienced after an inspection was carried out 3 months later on the flanges.

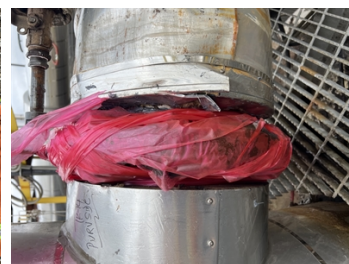
Repair completed with Superwrap II to protect against moisture ingress.
