Flanges leak sealed in a petrochemical plant.

ID: 9423

Industry: *Chemical & Petrochemical* Customer Location: *Hamilton, ON, Canada*
 Application: *VPF-Valves, Pipes and Fittings* Application Date: *March 2024*
 Substrate: *Carbon steel*
 Products: *Belzona 1212, Belzona 1982 (SuperWrap II), Belzona SuperWrap II, Belzona 9111 (Cleaner Degreaser)*

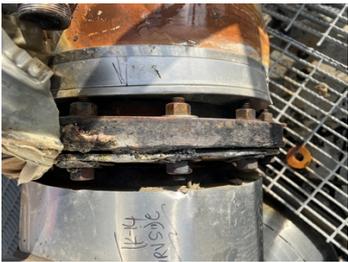
One of the flanges before surface preparation.

- Flanges were cleaned using Belzona 9111 and a power tool.
- Belzona 1212 was used to seal the leak.
- Belzona Superwrap II resin and accessories were used to give further protection.

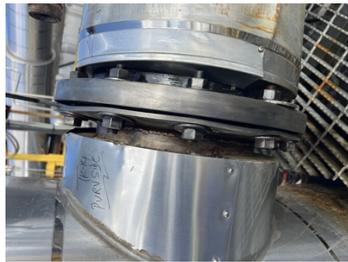
Flange after surface preparation.

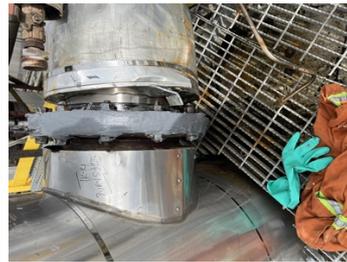
Flange after sealing with Belzona 1212.

Belzona repair solution was able to achieve seal the leaks under 6 minutes , allowing for a more robust superwrap application. The overall repair was carried out based on customer's expectation and no leak was experienced after an inspection was carried out 3 months later on the flanges.

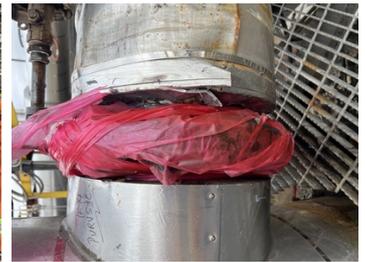
Repair completed with Superwrap II to protect against moisture ingress.
