## Silo cone gap sealing

ID: 9424

Application: *RPA-Roof Problem Areas*

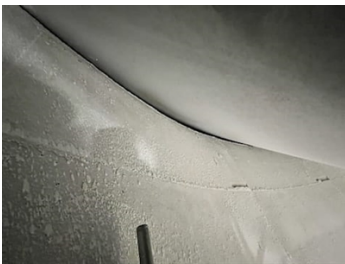
*White cement was falling off from a gap between the silo cone and the concrete wall which poses safety concerns for the employees.*

Gap between Silo cone before cleaning

A blower was used to remove cement from the surface and surroundings. Belzona 91111 was used to clean the surface. Belzona 1121 was then injected using Belzona pneumatic pistol into the gap to seal off the falling materials. Additional material was applied using Belzona applicator to make sure the area is well sealed.

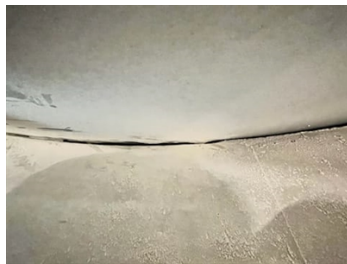
Gap before surface preparation.

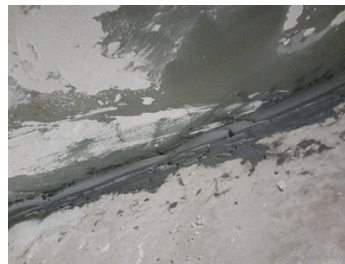
Gap after sealing with Belzona 1111.

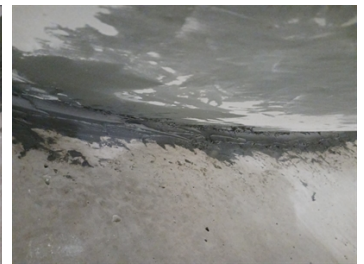
Final sealing with Belzona 1111.

Product cured on multiple substrate and the gap was sealed. After 24 hours, an inspection by the production team confirmed that materials were no longer falling from the gap hereby confirming a perfect seal. Customer is looking at sealing up such gaps with Belzona in the nearest future.
