Silo cone gap sealing

ID: 9424

Industry: *Mining & Quarrying*

Application: *RPA-Roof Problem Areas*

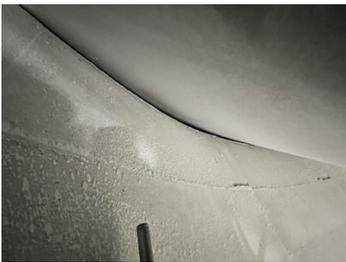
White cement was falling off from a gap between the silo cone and the concrete wall which poses safety concerns for the employees.

Gap between Silo cone before cleaning

A blower was used to remove cement from the surface and surroundings. Belzona 91111 was used to clean the surface. Belzona 1121 was then injected using Belzona pneumatic pistol into the gap to seal off the falling materials. Additional material was applied using Belzona applicator to make sure the area is well sealed.

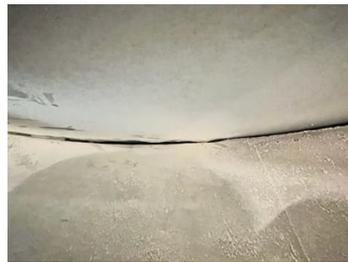
Gap before surface preparation.

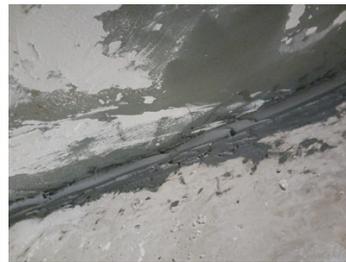
Gap after sealing with Belzona 1111.

Product cured on multiple substrate and the gap was sealed. After 24 hours, an inspection by the production team confirmed that materials were no longer falling from the gap hereby confirming a perfect seal. Customer is looking at sealing up such gaps with Belzona in the nearest future.

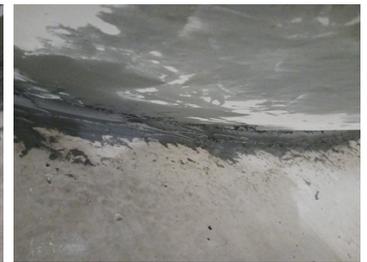
Final sealing with Belzona 1111.
