# Badly deteriorated process tank due to erosion corrosion and high alkalinity refurbished by Belzona.

ID: 9425

Application: *TCC-Tanks and Chemical Containment Areas*

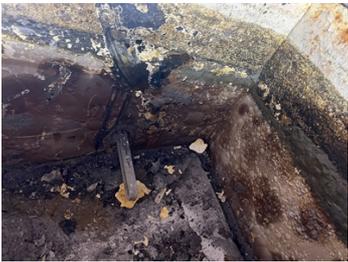
*Process tank was in a deplorable state after years of wear due to erosion corrosion.*

Tank before surface preparation.

- Tank was cleaned using a power tool and a cleaner/ degreaser.
- Internal of the tank was rebuild with Belzona 1121.
- The worn part at the top was reinforced with Belzona superwrap II.
- The internal was then coated with Belzona 1341 and external with Belzona 5811.

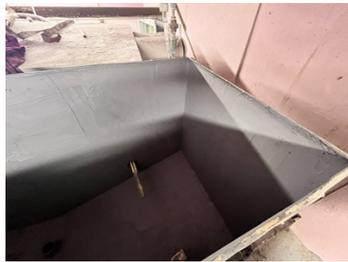
Tank after surface preparation and rebuilding with Belzona 1121.
