Badly deteriorated process tank due to erosion corrosion and high alkalinity refurbished by Belzona.

ID: 9425

Industry: Mining & Quarrying
Application: TCC-Tanks and Chemical Containment Areas
Substrate: Other
Products: Belzona 1121 (Super XL-Metal), Belzona 1341 (Supermetalgide), Belzona 1982 (SuperWrap II), Belzona SuperWrap II, Belzona 5811 (Immersion Grade)

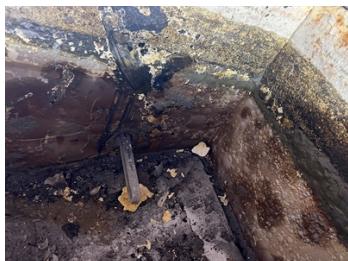
Process tank was in a deplorable state after years of wear due to erosion corrosion.

Tank before surface preparation.

- Tank was cleaned using a power tool and a cleaner/ degreaser.
- Internal of the tank was rebuild with Belzona 1121.
- The worn part at the top was reinforced with Belzona superwrap II.
- The internal was then coated with Belzona 1341 and external with Belzona 5811.

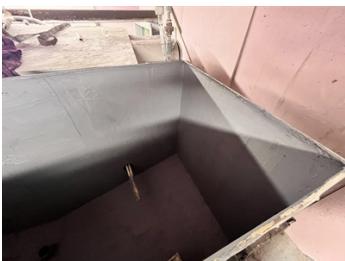
Tank after surface preparation and rebuilding with Belzona 1121.

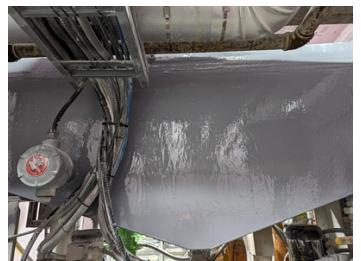
Tank External after coating with Belzona 5811.
