# BELZONA WEATHERPROOFS BALCONY

**Customer Location:** Housing Association, Merseyside, UK  
**Application Date:** February 2007

Water was finding its way into the flats from the balconies. Customer needed a weatherproof and non-slip solution.

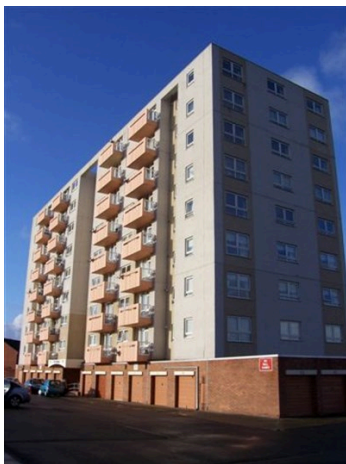
- \* 1. One of the three blocks of flat ,
- \* 2. Loose asphalt being removed ,
- \* 3. Belzona 3131 being applied ,
- \* 4. Aggregate being scattered onto top coat of Belzona 3131 ,

Asphalt access balconies on multi-story flats.
