PVC Chiller Internal rebuild w/ Belzona 1121 and Belzona 1321

ID: 9432

Industry: Oil & Gas

Customer Location: Plaquemine, LA

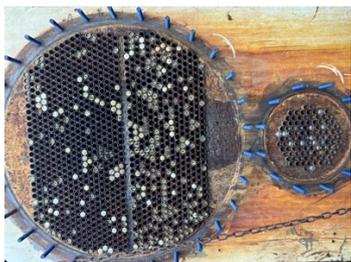
Before Repair

Client found extreme corrosion and had minimal down time for repair.

Abrasive blasted entire areas to be coated to SSPC SP 10 as per product manufactures recommendations.

Rebuilt damaged internal areas as identified with Belzona 1121

Coated all internal wet areas identified with Belzona 1321 Ceramic S Metal
