Ammonium Sulphate Feed Tank Restored with Belzona SuperWrap II

ID: 9434

Composite wrap system curbs corrosion under insulation at nickel mine

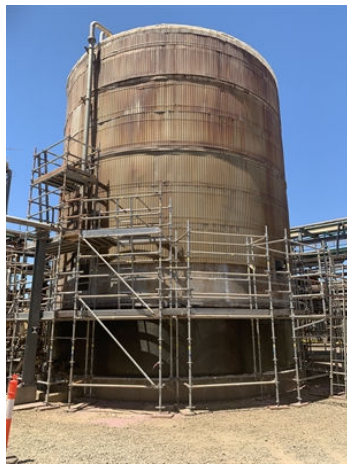
Corroded tank in need of long-term repair and protection
