# Ammonium Sulphate Feed Tank Restored with Belzona SuperWrap II

Industry: Mining & Quarrying  
Application: VPF-Valves, Pipes and Fittings  
Substrate: Stainless-steel  
Products: Belzona SuperWrap II

Customer Location: Australia  
Application Date: January 2024

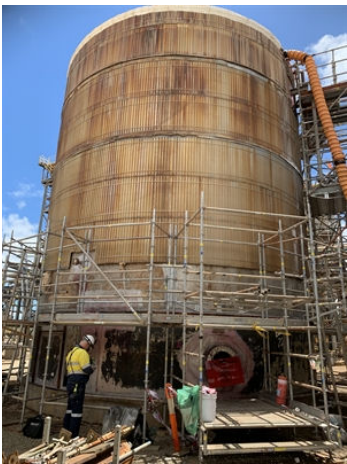
The Customer's stainless steel feed tank was suffering from corrosion under insulation and chloride induced stress corrosion cracking.

Corrosion under insulation on an ammonium sulphate feed tank

Firstly, all traces of oil and grease contamination were removed using a suitable Rezitech Degreaser. Following this, the surfaces were grit-blasted to provide a surface cleanliness compliant with ISO 8501-1 SA 2½ (ASNZ 1627.4 class 2.5) with a minimum 75 µm (3 mil) rough angular profile.

Once the surface was prepared, the Belzona 9381 reinforcement sheet was measured out and then wetted out with the Belzona resin system. The resin was then systematically applied to the areas to be repaired. Following this, the Belzona reinforcement sheets were then applied to the tank in three layers. The compression film was then added to the top of the application area. Next, using a roller, the Belzona SuperWrap II composite wrap system was then spread, rolled and compressed to the surface of the tank. The system was then left to cure for approximately eight hours.

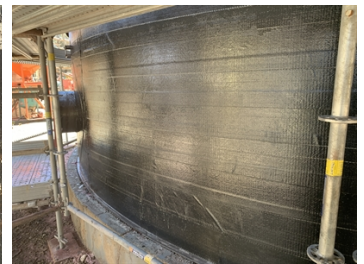
Stainless steel feed tank repaired and protected
