# Repair of damaged flowing parts of the TG4 storage pump

Industry: *Power* Customer Location: *Cierny Vah*  
Application: *TCC-Tanks and Chemical Containment* Application Date: *June 2015*  
Areas  
Substrate: *Carbon steel*  
Products: *Belzona 1311 (Ceramic R-Metal), Belzona 1341 (Supermetalgilde)*

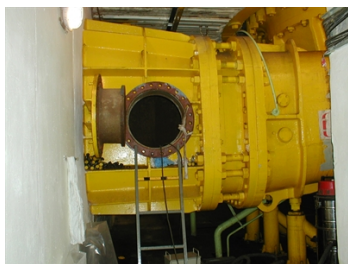
*Damage to the pump surface by cavitation and the formation of a rough surface.*

View from the outside

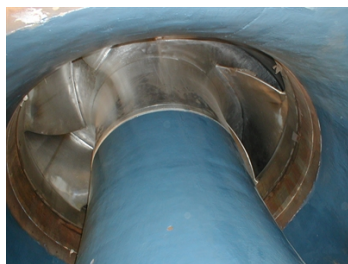
Belzona 1341 application

Sealing of the working space under the impellers of the first stage. Drying of the repair area, degreasing of the surface with BELZONA 9121. Blasting of the repaired surfaces to the required standard Sa 2.5 with extraction cleaning of the space and dedusting of the area. Local repair of places and areas where the base material has been lost with BELZONA 1311 Ceramic R Metal. Application of BELZONA 1341 Supermetalgilde to the surface to be repaired in two coats with a thickness of min. 500 µm.

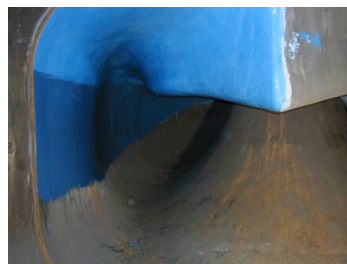
Belzona 1341 application

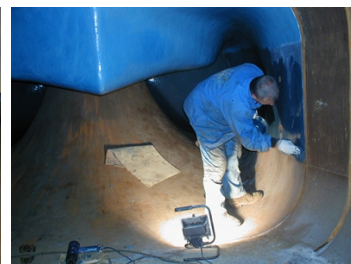
Belzona 1341 application
