Repair of damaged flowing parts of the TG4 storage pump

ID: 9435

Customer Location: Cierny Vah Slovakia

Products: Belzona 1311 (Ceramic R-Metal), Belzona 1341 (Supermetalglide)

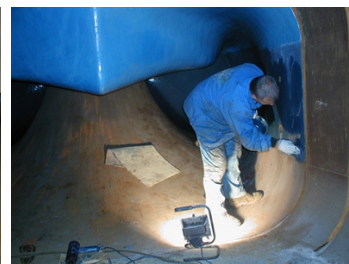
Belzona 1341 application

Sealing of the working space under the impellers of the first stage. Drying of the repair area, degreasing of the surface with BELZONA 9121. Blasting of the repaired surfaces to the required standard Sa 2.5 with extraction cleaning of the space and dedusting of the area. Local repair of places and areas where the base material has been lost with BELZONA 1311 Ceramic R Metal. Application of BELZONA 1341 Supermetalglide to the surface to be repaired in two coats with a thickness of min. 500 µm.
