Wind Turbine Blades

ID: 9436

Industry: Power
Application: FBC-Fans, Blowers and Compressors

Substrate: GFRP
Products: Belzona 5711, Belzona 5721

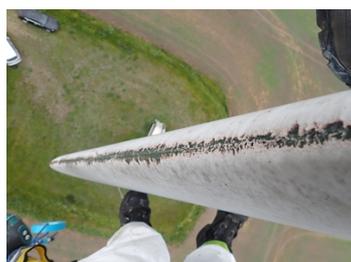
Due to natural wear and weathering, 14 onshore wind turbines were exhibiting damaged leading edges. The turbines were outside of the Manufacturer's warranty period.

Damaged leading edge

Surface preparation was carried out, followed by the direct application of 90 kg (198.4 lbs) of Belzona 5711 from self-mixing cartridges onto the blade. The repair area was contoured using a piece of Belzona mixing board. Once cured, a visual inspection was conducted to ensure the application's readiness for overcoating with 144 kg (317.5 lbs) of Belzona 5721. Using a short-bristled brush, this system was then applied to the leading edge and left to cure. The application was carried out in accordance with Belzona System Leaflet FBC -16.

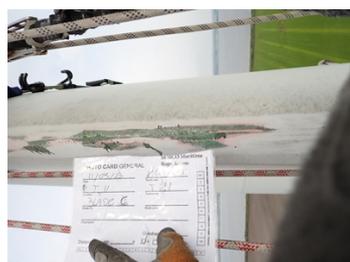
Wind turbine in need of repair and protection

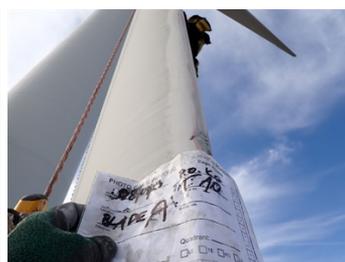
Application of Belzona 5711 and Belzona 5721 completed
