Wind Turbine Blades

ID: 9436

Industry: Power
Application: FBC-Fans, Blowers and Compressors

Customer Location: Denmark
Application Date: September 2023

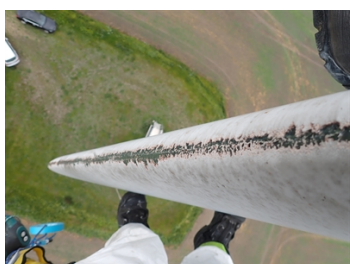
Due to natural wear and weathering, 14 onshore wind turbines were exhibiting damaged leading edges. The turbines were outside of the Manufacturer's warranty period.

Damaged leading edge

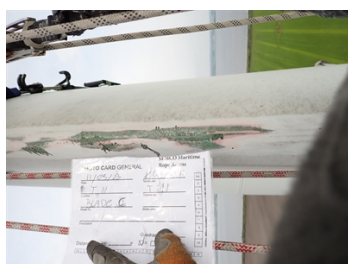
Wind turbine in need of repair and protection
