Wind Turbine Blades

ID: 9436

Industry: Power
Application: FBC-Fans, Blowers and Compressors

Substrate: GFRP
Products: Belzona 5711, Belzona 5721

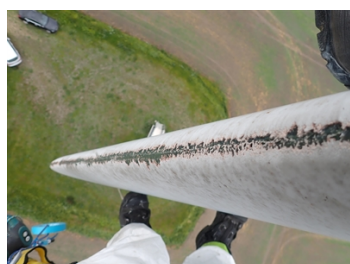
Due to natural wear and weathering, 14 onshore wind turbines were exhibiting damaged leading edges. The turbines were outside of the Manufacturer's warranty period.

Damaged leading edge

Surface preparation was carried out, followed by the direct application of 90 kg (198.4 lbs) of Belzona 5711 from self-mixing cartridges onto the blade. The repair area was contoured using a piece of Belzona mixing board. Once cured, a visual inspection was conducted to ensure the application's readiness for overcoating with 144 kg (317.5 lbs) of Belzona 5721. Using a short-bristled brush, this system was then applied to the leading edge and left to cure. The application was carried out in accordance with Belzona System Leaflet FBC -16.
