Laeis press – repair and machining of the outer surfaces of the Ø 1200 piston

ID: 9437

Industry: Mining & Quarrying
Application: ENC-Engines and Casings
Substrate: Carbon steel
Products: Belzona 1311 (Ceramic R-Metal)

Customer Location: Lubenik Slovakia
Application Date: August 2016

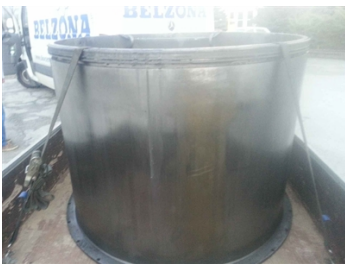
The outer surface of the piston was damaged by grooving. Grooves were created during the operation of the device by unintentional ingress of the product into the inner space of the cylinder.

Damaged cylinder surface.

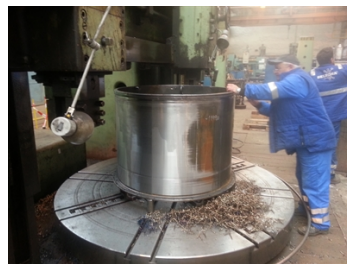
Centering of the piston in the machining device, turning the surface around the entire circumference to a depth of 1.6 mm.

Centering of the piston in the machining device, turning the surface around the entire circumference to a depth of 1.6 mm. Abrasive blasting of the machined surface to a roughness of 75 µm. Application of BELZONA 1311 sealant in the required thickness (approx. 2-3 mm) with a machining allowance. Turning of the part with the addition of grinding, repair of any air bubbles. Final grinding and polishing of the surface to the nominal dimension and surface roughness.

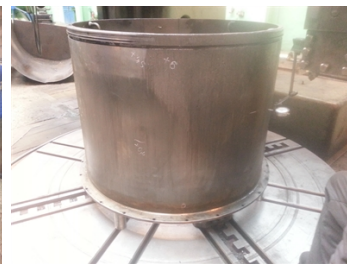
Application of BELZONA 1311

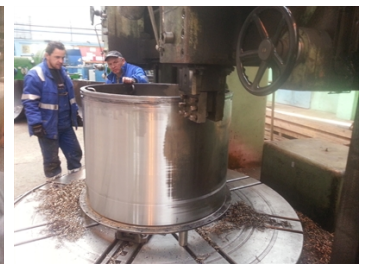
Final grinding and polishing of the surface to the nominal dimension and surface roughness
