Laeis press – repair and machining of the outer surfaces of the Ø 1200 piston

ID: 9437

Industry: *Mining & Quarrying*
Application: *ENC-Engines and Casings*
Substrate: *Carbon steel*
Products: *Belzona 1311 (Ceramic R-Metal)*

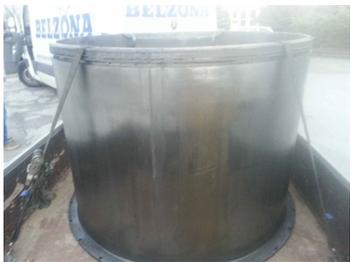
The outer surface of the piston was damaged by grooving. Grooves were created during the operation of the device by unintentional ingress of the product into the inner space of the cylinder.

Damaged cylinder surface.

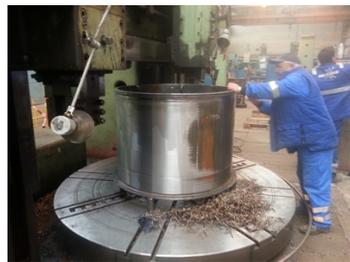
Centering of the piston in the machining device, turning the surface around the entire circumference to a depth of 1.6 mm.

Centering of the piston in the machining device, turning the surface around the entire circumference to a depth of 1.6 mm. Abrasive blasting of the machined surface to a roughness of 75 µm. Application of BELZONA 1311 sealant in the required thickness (approx. 2-3 mm) with a machining allowance. Turning of the part with the addition of grinding, repair of any air bubbles. Final grinding and polishing of the surface to the nominal dimension and surface roughness.

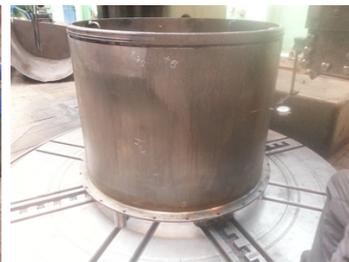
Application of BELZONA 1311

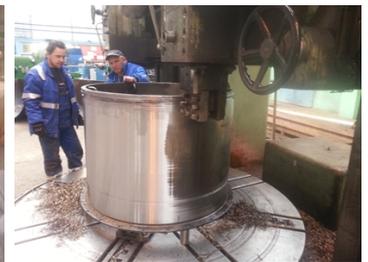
Final grinding and polishing of the surface to the nominal dimension and surface roughness
