Refurbishment of exchangers

ID: 9438

Industry: Power

Application: HEX-Heat Exchangers

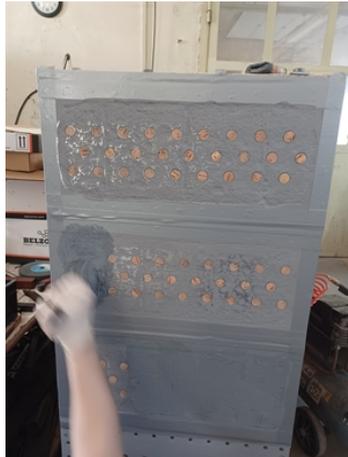
Damage to the exchanger tube - corrosion, leakage, poor cooling effect of heat exchangers.

Damage to the exchanger tube. Repair using cork plugs.

Blasting of the front surfaces of the tube and lid (including covers from the inside) to the required parameters (Sa 2.5, min. roughness 75µm). Desalination and re-blasting. Alignment of protruding pipes. Pipe plugging. Sealing of damaged parts of pipe fronts and baffle lids (including flanges on the inside, welding of auxiliary guide rails, disassembly after sealing) with Belzona 1111, 3 to 5 mm thick. Sanding and double-sided dismantling of plugs from pipes. Machine machining and alignment of the tube face and sealing surface of the lids, easy blasting of the tube heads. Application of Belzona 4311 sequentially in two layers of 2 x 250 µm thickness to the surface of the tubing and lids (including flanges from the inside).

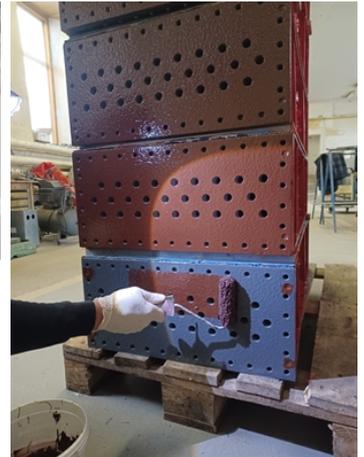
Repair of the cover partition

Application of the second layer of Belzona 4311 product.
