# Refurbishment of a marine caisson

ID: 9439

Industry: Marine  
Application: CEP-Centrifugal Pumps  
Substrate: Stainless-steel  
Products: Belzona 1111 (Super Metal), Belzona 1331, Belzona 5811 (Immersion Grade)

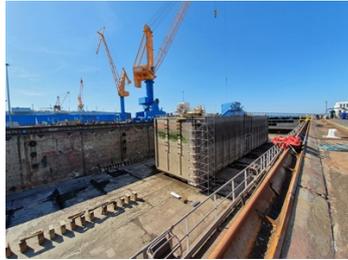
This caisson was suffering from significant corrosion, leading to an ineffective seal. The two steel installation surfaces (18000 x 1100 mm), sealed in the concrete of the boat-carrier, were completely corroded and damaged. The surface condition no longer made it possible to obtain full waterproofing when installing the louver closing seal.

Caisson before the Belzona repair

The client was responsible for setting up the scaffolding and washing HP and salt away for saline decontamination. Alliatech could then begin the application with sandblasting (SA2.5 /75µ roughness) and application of Belzona 5811 in 250µm to prevent corrosion before rebuilding with Belzona 1111. For final protection, two coats of Belzona 1331 were applied with a brush.

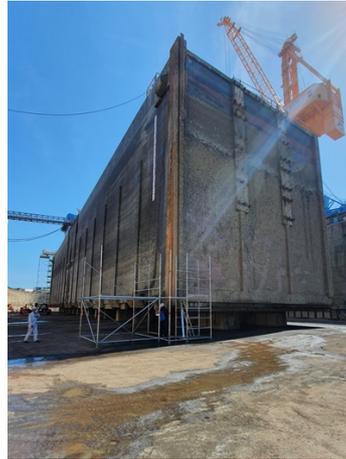
Caisson before the Belzona repair from a different perspective
