BELZONA WEATHERPOOFS POROUS STONework

Industry: *Buildings & Structures*
Application: *WPA-Wall Problem Areas*
Substrate: *Sandstone*
Products: ** Belzona® 5122 (Clear Cladding Concentrate),*

Customer Location: *Private House, Manchester, England*
Application Date: *August 2007*

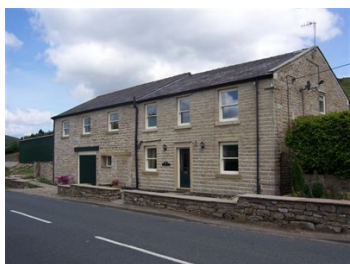
- * View of property ,
- * Windows masked up and ready to go ,
- * Applying Belzona® 5122 with spray unit ,
- * Application close up ,
