# BELZONA WEATHERPOOFS POROUS STONework

ID: 944

Industry: *Buildings & Structures*  
Application: *WPA-Wall Problem Areas*  
Substrate: *Sandstone*  
Products: *\* Belzona® 5122 (Clear Cladding Concentrate),*

Customer Location: *Private House, Manchester, England*  
Application Date: *August 2007*

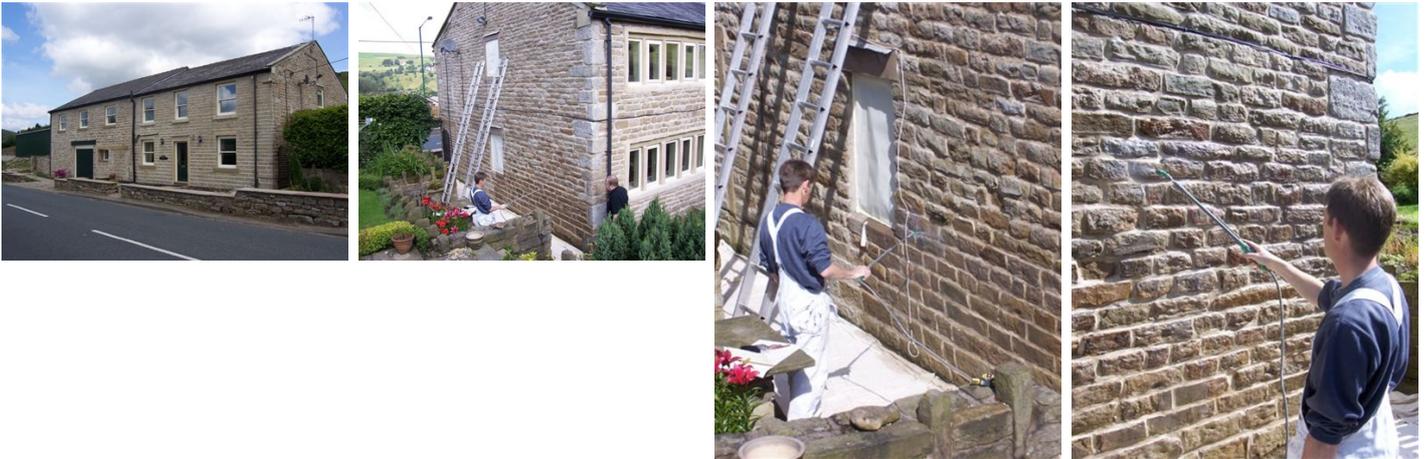
*House had been recently renovated and sand blasted externally. This process removed the wetherproofing properties of the stonework and as a result moisture was penetrating into the house.*

- \* View of property ,
- \* Windows masked up and ready to go ,
- \* Applying Belzona® 5122 with spray unit ,
- \* Application close up ,

Application was carried out in accordance with Belzona Know-How System Leaflet WPA-8.

Customer did not want a sheen left on the building once coated. Material of choice also had to be microporous.
